## Windstorm Mitigation Report (OIR-B1-1802)

Lake Villas Q and R Homeowners Association, Inc.

54-58 Lake Villa Way

As of 6/14/2022 | FPAT File# MUD2214404

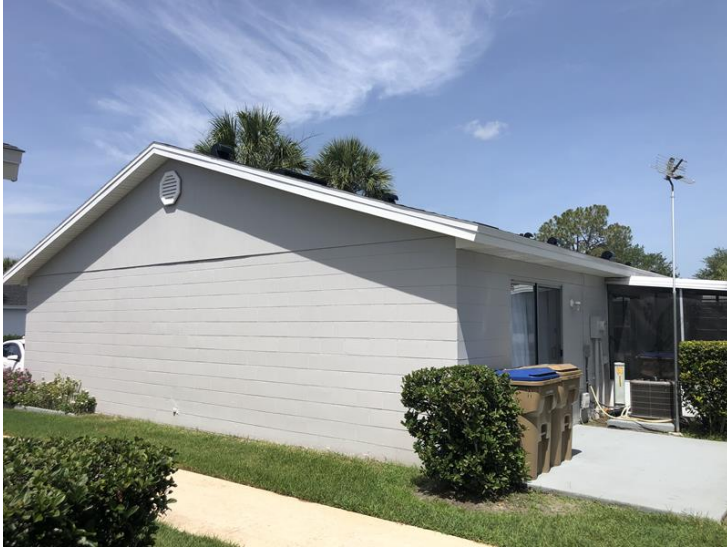
Exterior Elevation

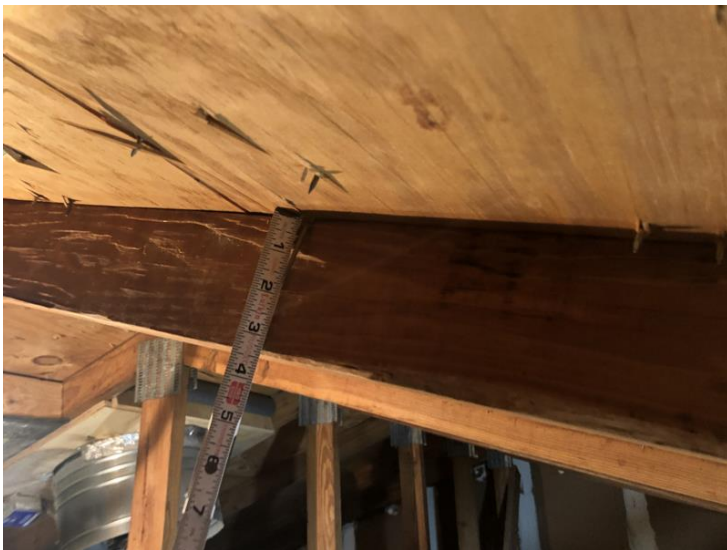
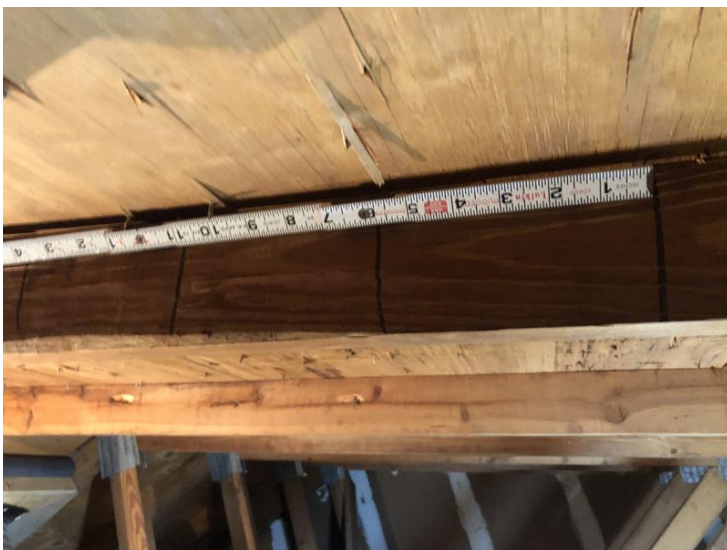
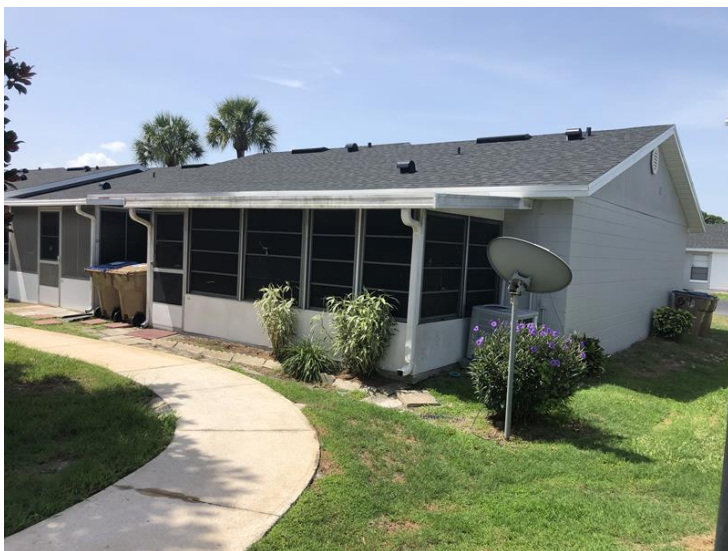
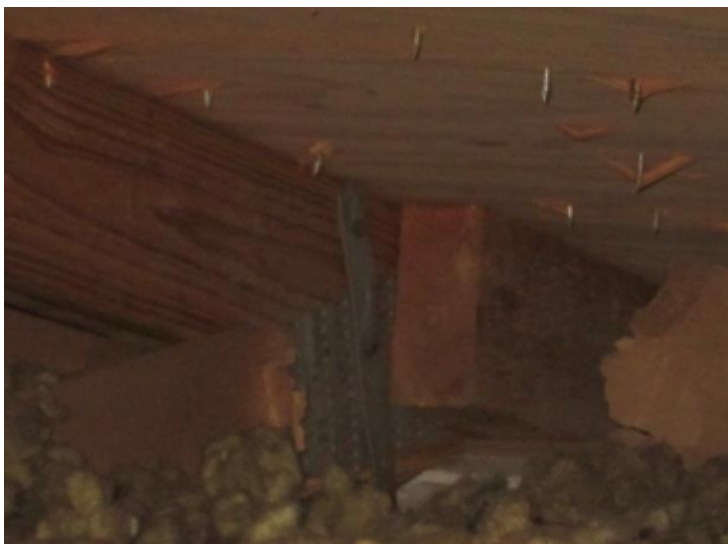
| <b>3. Roof Deck Attachment:</b><br>Comments: | <b>Level C</b><br>Inspection verified 1/2" plywood roof deck attached with 8d nails at a minimum 6" on the edge & 6" in the field. |
| <b>4. Roof to Wall Attachment:</b><br>Comments: | <b>Toe Nails</b><br>Inspection verified embedded straps fastened with less than three nails. |
| <b>5. Roof Geometry:</b><br>Comments: | <b>Other Roof</b><br>Inspection verified a gable roof shape. |
| <b>6. SWR:</b><br>Comments: | <b>No</b><br>Inspection verified no secondary water resistance. |

Roof Construction
