Windstorm Mitigation Report (OIR-B1-1802)

Lake Villas Q and R Homeowners Association, Inc.

89-94 Lake Villa Way

As of 6/14/2022 | FPAT File# MUD2214404

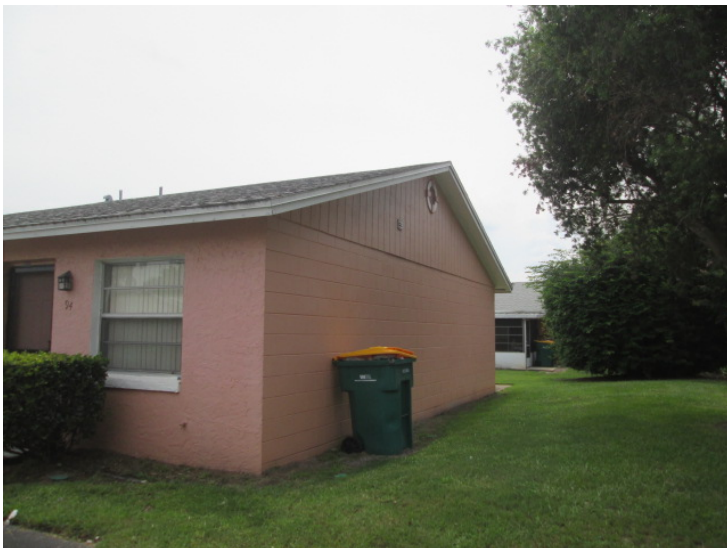
Exterior Elevation

Comments: | Other Roof
Inspection verified a gable roof shape. |

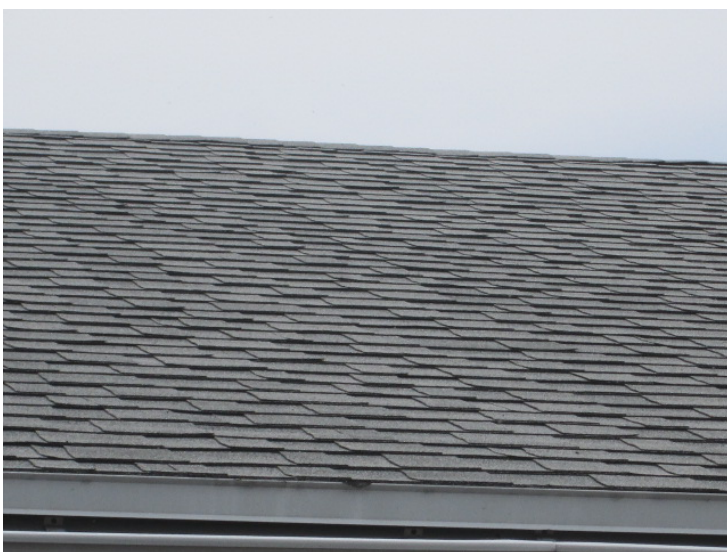
Roof Construction

Comments: | Level C
Inspection verified 1/2" plywood roof deck attached with 8d nails at a minimum 6" on the edge & 6" in the field. |

Comments: | Toe Nails
Inspection verified embedded straps fastened with less than three nails. |
