## Windstorm Mitigation Report (OIR-B1-1802)

Lake Villas Q and R Homeowners Association, Inc.

40-44 Lake Villa Way

As of 6/14/2022 | FPAT File# MUD2214404

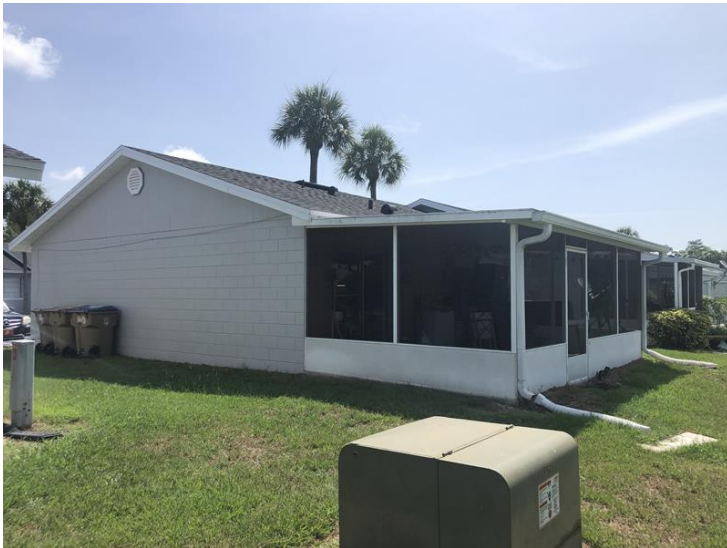
Exterior Elevation

| <b>5. Roof Geometry:</b><br>Comments: | <b>Other Roof</b><br>Inspection verified a gable roof shape. |

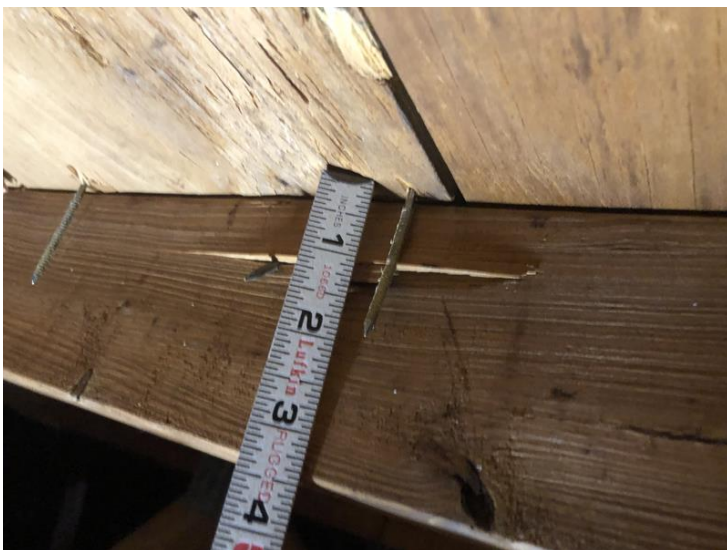
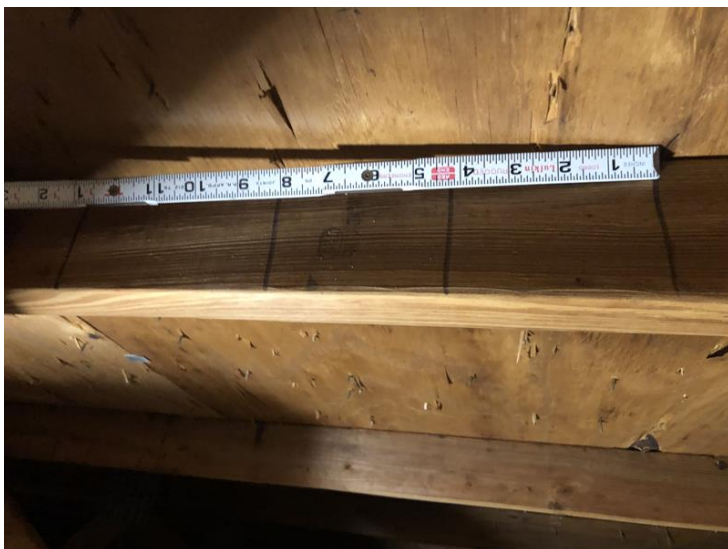
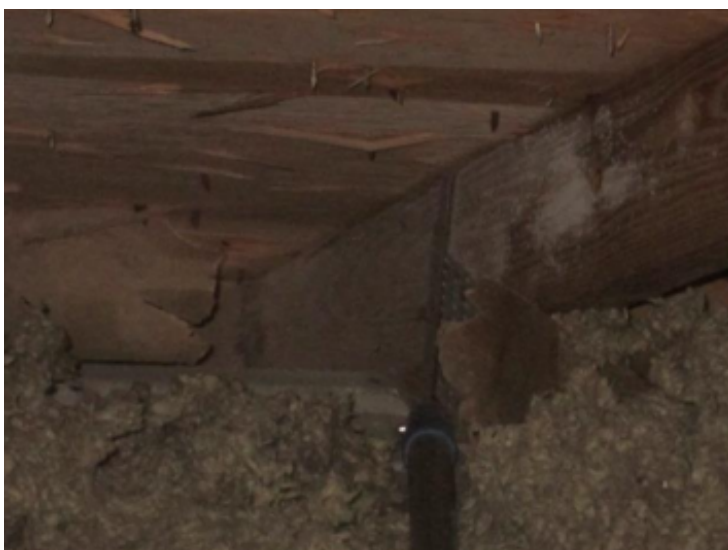
Roof Construction

| <b>3. Roof Deck Attachment:</b><br>Comments: | <b>Level C</b><br>Inspection verified 1/2" plywood roof deck attached with 8d nails at a minimum 6" on the edge & 6" in the field. |
| <b>4. Roof to Wall Attachment:</b><br>Comments: | <b>Toe Nails</b><br>Inspection verified embedded straps fastened with less than three nails. |
| <b>6. SWR:</b><br>Comments: | <b>No</b><br>Inspection verified no secondary water resistance. |
