## Windstorm Mitigation Report (OIR-B1-1802)

Lake Villas Q and R Homeowners Association, Inc.

128-132 Lake Villa Way

As of 6/14/2022 | FPAT File# MUD2214404

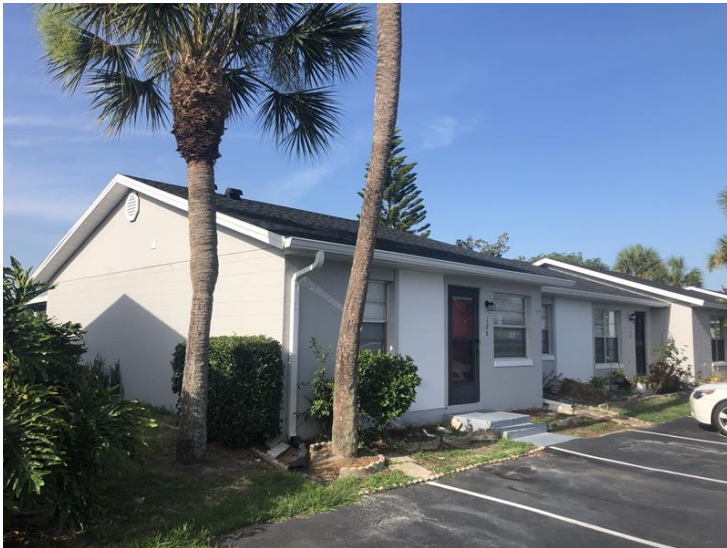
Exterior Elevation

| <b>5. Roof Geometry:</b><br>Comments: | <b>Other Roof</b><br>Inspection verified a gable roof shape. |

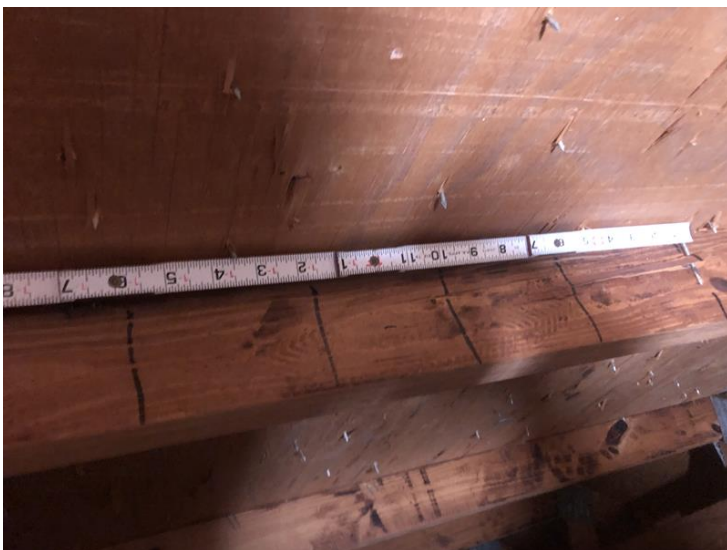
Roof Construction

| <b>3. Roof Deck Attachment:</b><br>Comments: | <b>Level C</b><br>Inspection verified 1/2" plywood roof deck attached with 8d nails at a minimum 6" on the edge & 6" in the field. |

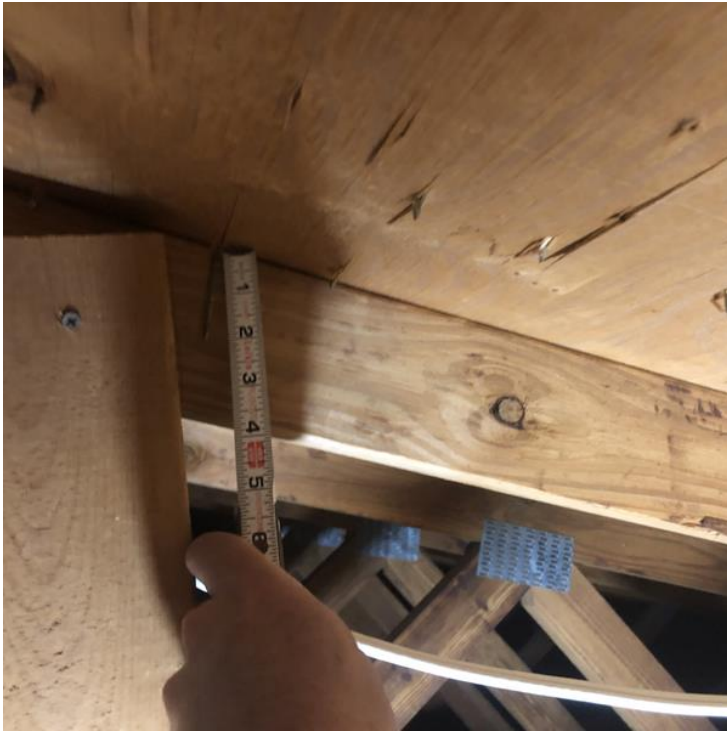
Roof Construction

| <b>4. Roof to Wall Attachment:</b><br>Comments: | <b>Toe Nails</b><br>Inspection verified embedded straps fastened with less than three nails. |
