## Windstorm Mitigation Report (OIR-B1-1802)

Lake Villas Q and R Homeowners Association, Inc.

45-49 Lake Villa Way

As of 6/14/2022 | FPAT File# MUD2214404

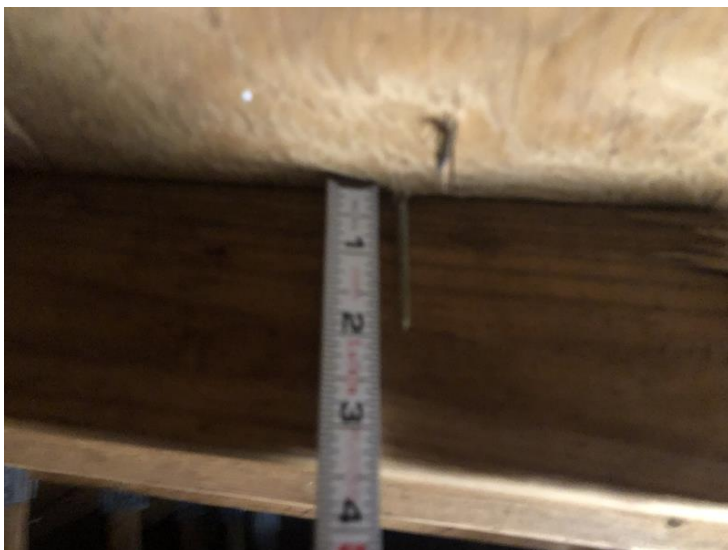
Roof Construction

| <b>3. Roof Deck Attachment:</b><br>Comments: | <b>Level C</b><br>Inspection verified 1/2" plywood roof deck attached with 8d nails at a minimum 6" on the edge & 6" in the field.<br>plywood roof deck attached with staples at a minimum of 6" on the edge & 12" in the field. |
| <b>4. Roof to Wall Attachment:</b><br>Comments: | <b>Toe Nails</b><br>Inspection verified embedded straps fastened with less than three nails. |
