## Windstorm Mitigation Report (OIR-B1-1802)

Lake Villas Q and R Homeowners Association, Inc.

30-34 Lake Villa Way

As of 6/14/2022 | FPAT File# MUD2214404

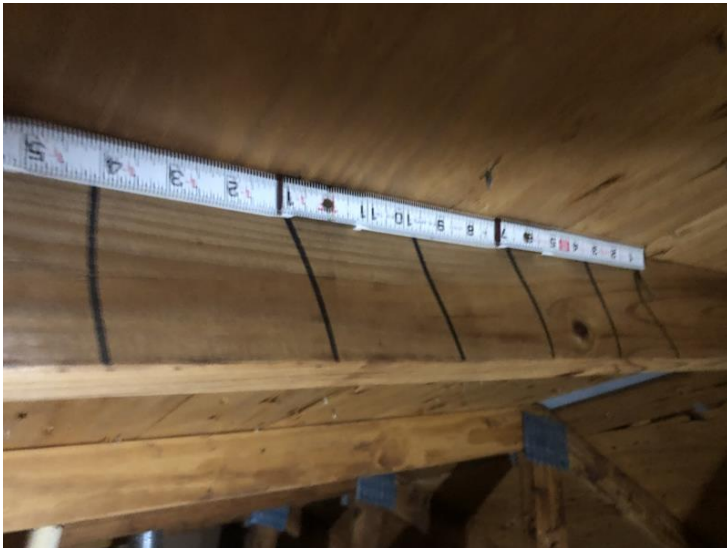
Roof Construction

| <b>3. Roof Deck Attachment:</b><br>Comments: | <b>Level C</b><br>Inspection verified 1/2" plywood roof deck attached with 8d nails at a minimum 6" on the edge & 6" in the field. |
