## Windstorm Mitigation Report (OIR-B1-1802)

Lake Villas Q and R Homeowners Association, Inc.

122-127 Lake Villa Way

As of 6/14/2022 | FPAT File# MUD2214404

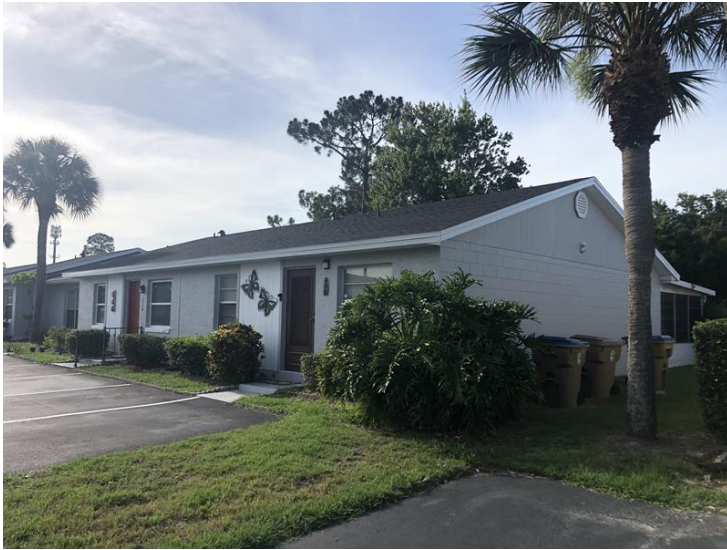
Exterior Elevation

| 5. <b>Roof Geometry:</b><br>Comments: | <b>Other Roof</b><br>Inspection verified a gable roof shape. |

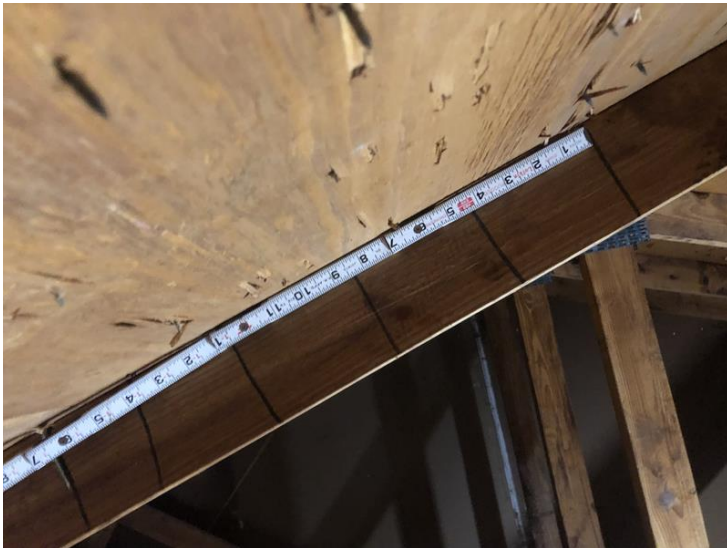
Roof Construction

| 3. <b>Roof Deck Attachment:</b><br>Comments: | <b>Level C</b><br>Inspection verified 1/2" plywood roof deck attached with 8d nails at a minimum 6" on the edge & 6" in the field. |
