Windstorm Mitigation Report (OIR-B1-1802)

Lake Villas Q and R Homeowners Association, Inc.

73-76 Lake Villa Way

As of 6/14/2022 | FPAT File# MUD2214404

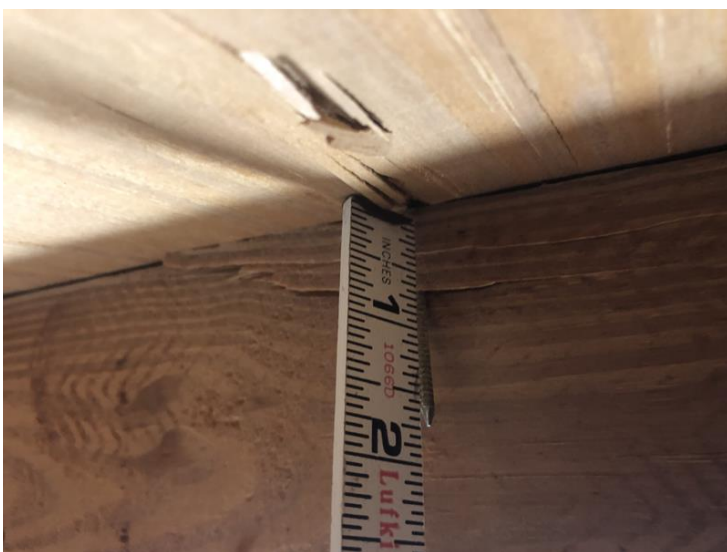
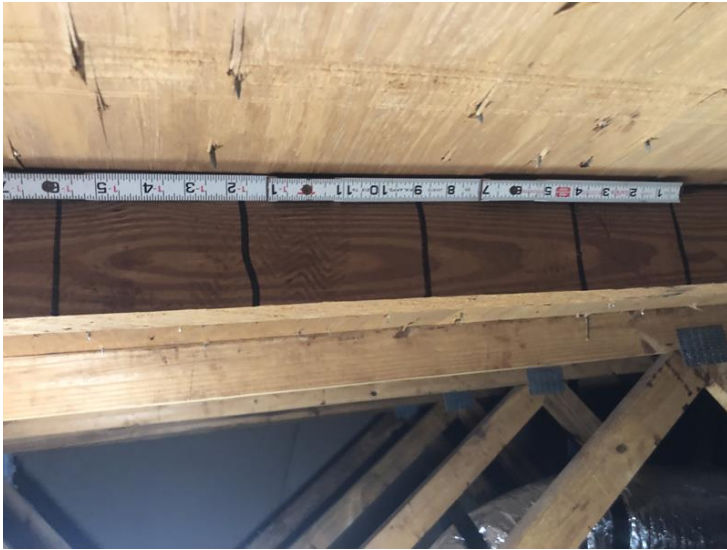
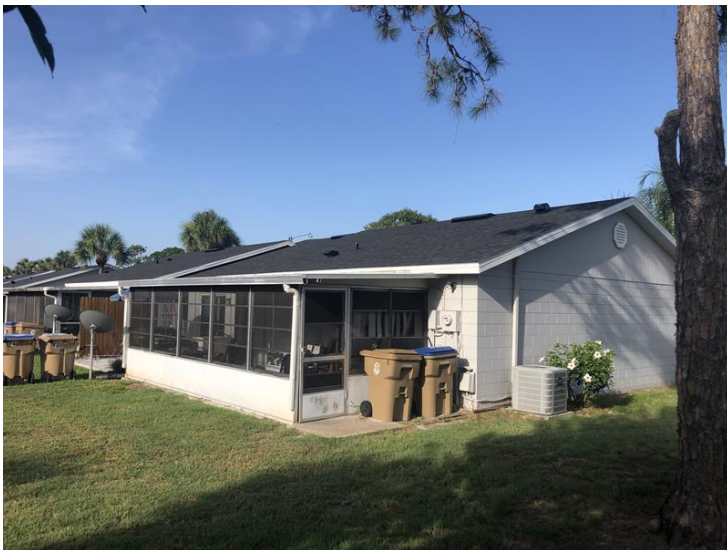
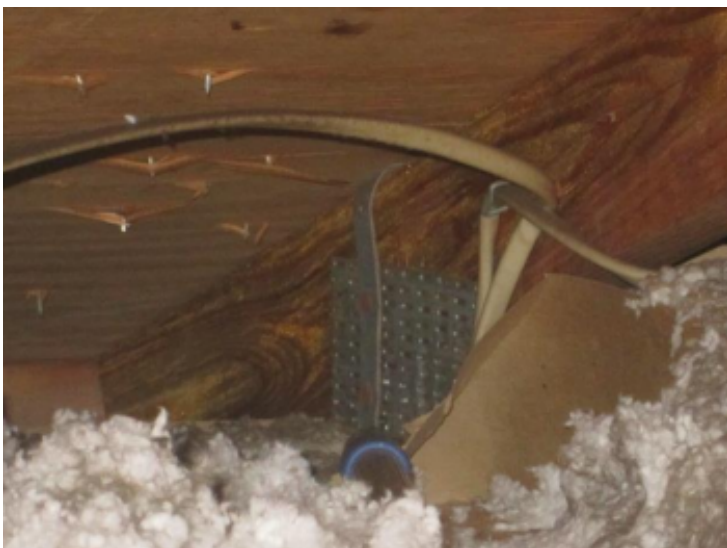
Comments: | Level C
Inspection verified 1/2" plywood roof deck attached with 8d nails at a minimum 6" on the edge & 6" in the field. |

Comments: | Toe Nails
Inspection verified embedded straps fastened with less than three nails. |

Comments: | Other Roof
Inspection verified a gable roof shape. |

Comments: | No
Inspection verified no secondary water resistance. |
