Windstorm Mitigation Report (OIR-B1-1802)

Lake Villas Q and R Homeowners Association, Inc.

84-88 Lake Villa Way

As of 6/14/2022 | FPAT File# MUD2214404

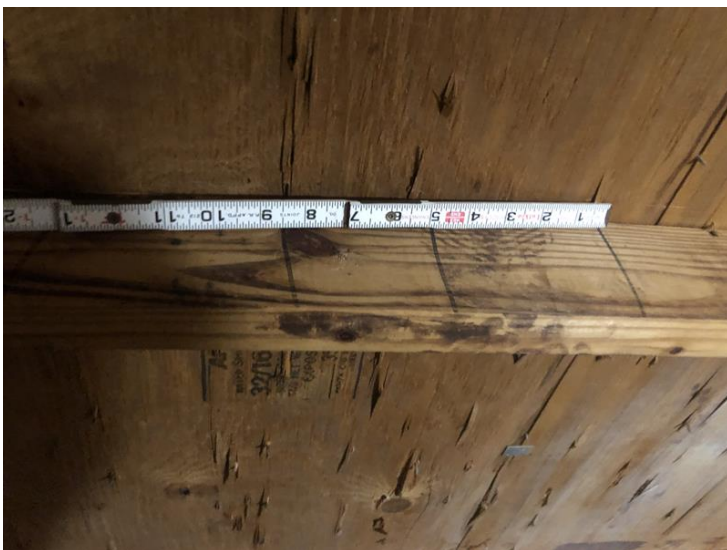
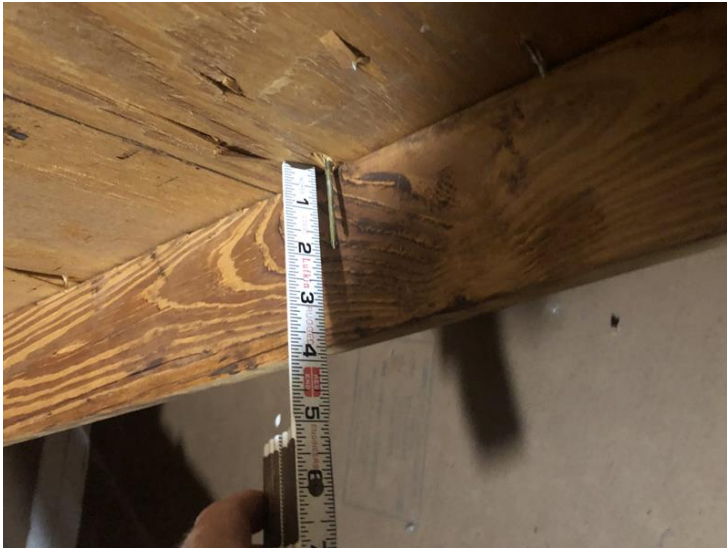
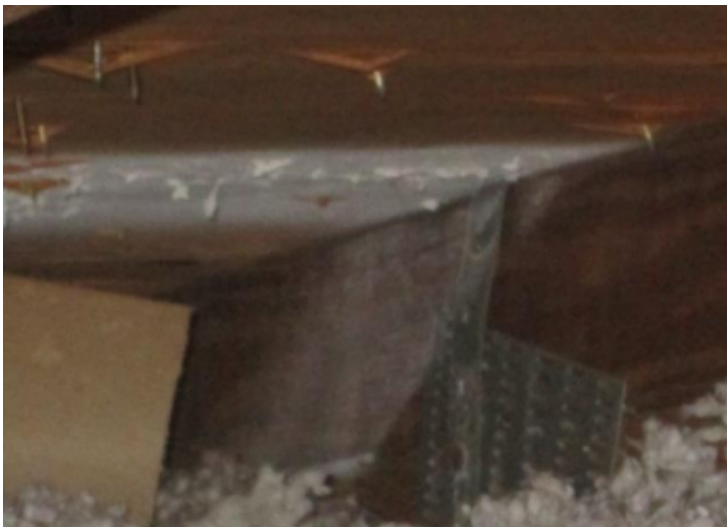
Roof Construction

Comments: | Level C
Inspection verified 1/2" plywood roof deck attached with 8d nails at a minimum 6" on the edge & 6" in the field. |

Comments: | Toe Nails
Inspection verified embedded straps fastened with less than three nails. |

Comments: | Other Roof
Inspection verified a gable roof shape. |
