Windstorm Mitigation Report (OIR-B1-1802)

Lake Villas Q and R Homeowners Association, Inc.

25-29 Lake Villa Way

As of 6/14/2022 | FPAT File# MUD2214404

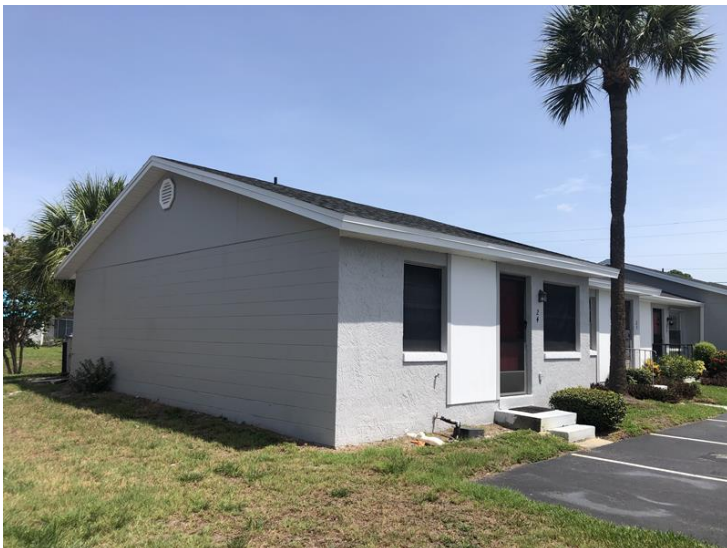
Exterior Elevation

Comments: | Other Roof
Inspection verified a gable roof shape. |

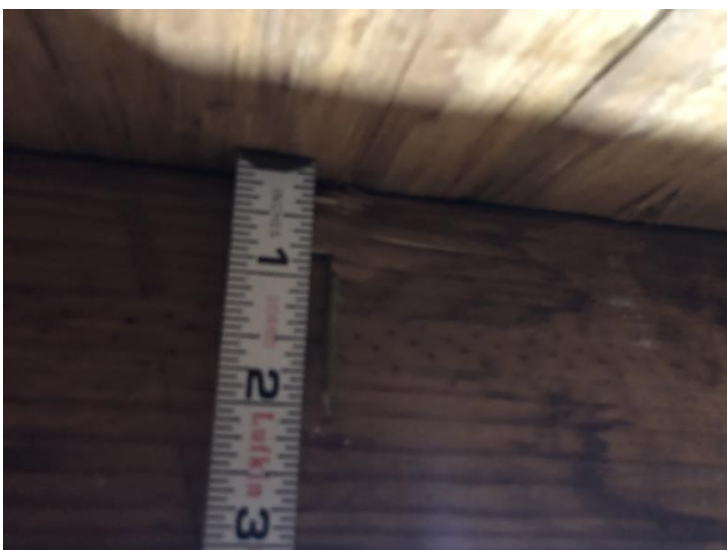
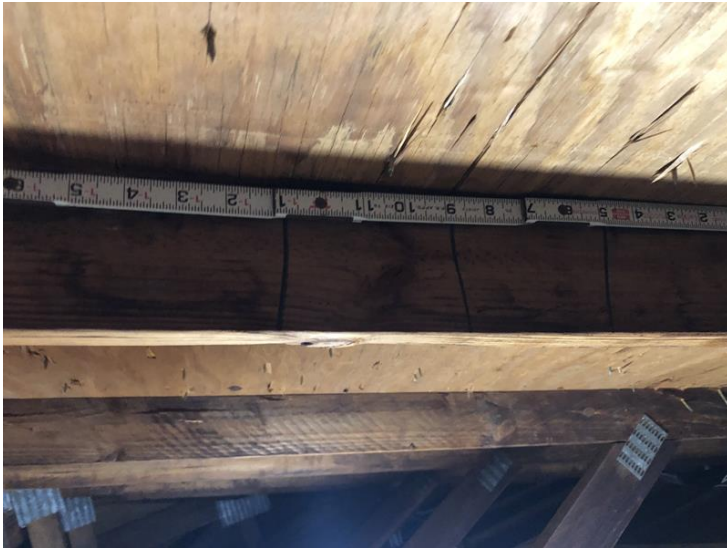
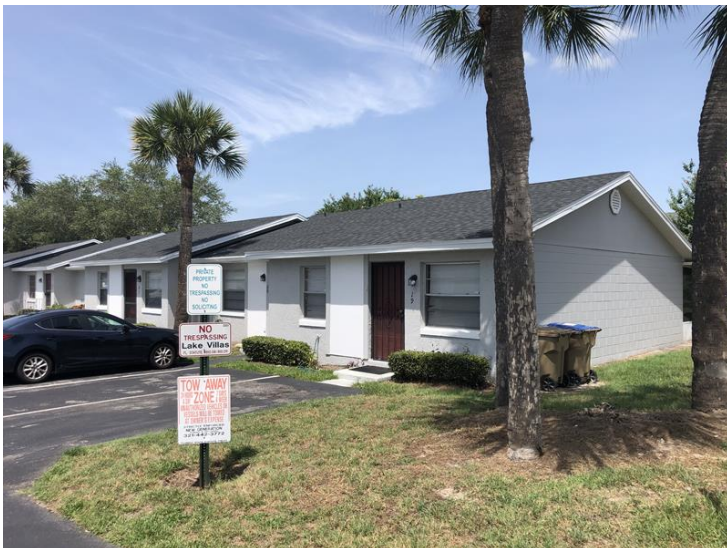
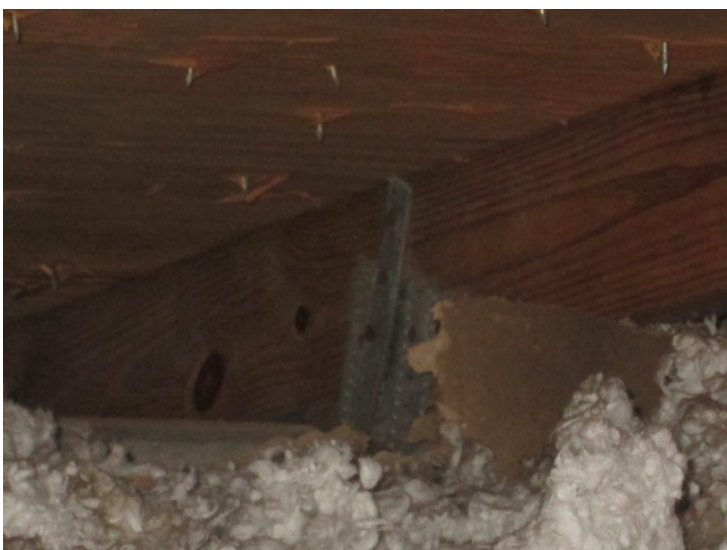
Roof Construction

Comments: | Level C
Inspection verified 1/2" plywood roof deck attached with 8d nails at a minimum 6" on the edge & 6" in the field. |

Comments: | Clips
Inspection verified embedded straps fastened with a minimum of three nails. |
