## Windstorm Mitigation Report (OIR-B1-1802)

Lake Villas Q and R Homeowners Association, Inc.

95-98 Lake Villa Way

As of 6/14/2022 | FPAT File# MUD2214404

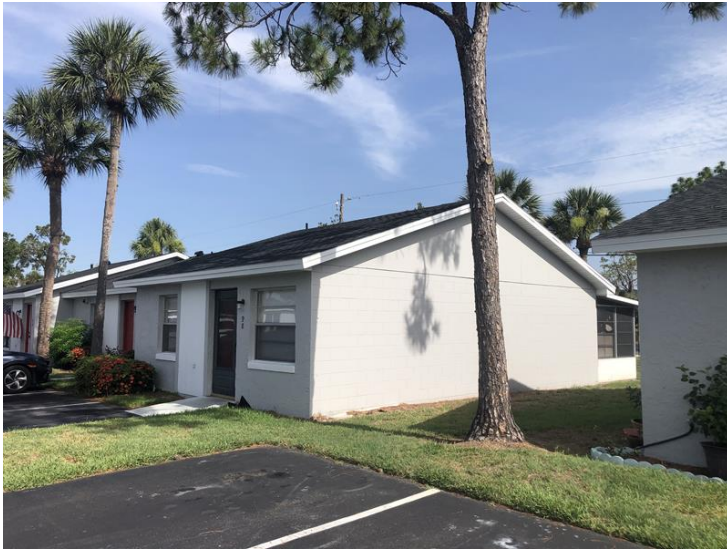
Exterior Elevation

| <b>5. Roof Geometry:</b><br>Comments: | <b>Other Roof</b><br>Inspection verified a gable roof shape. |

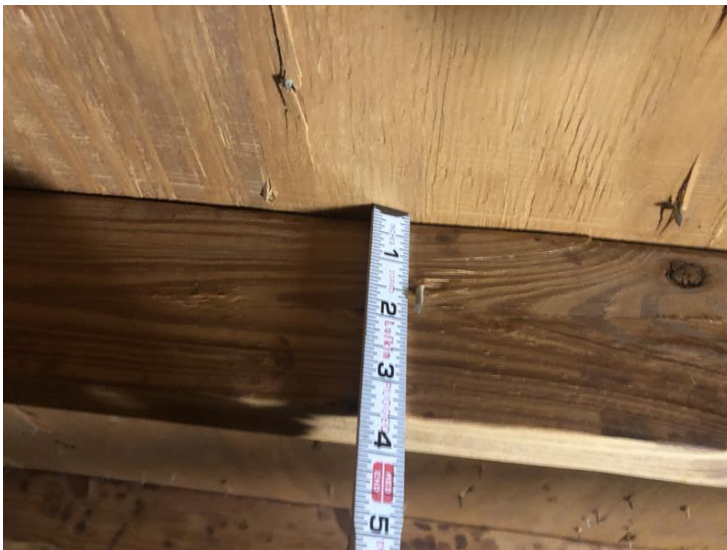
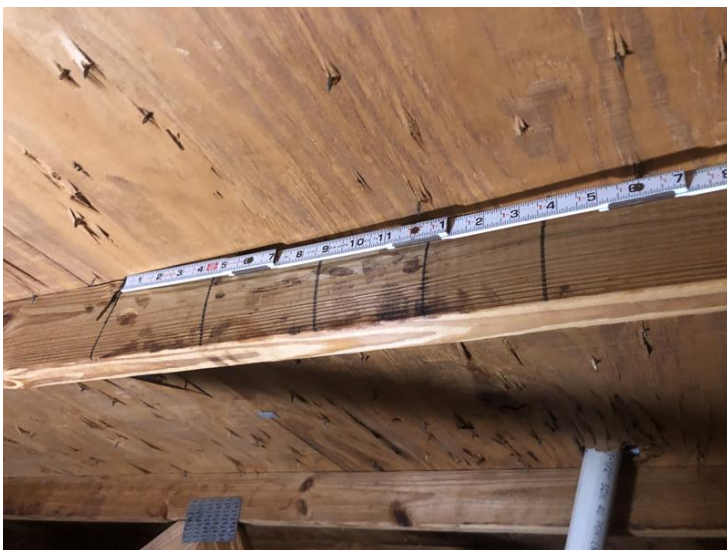
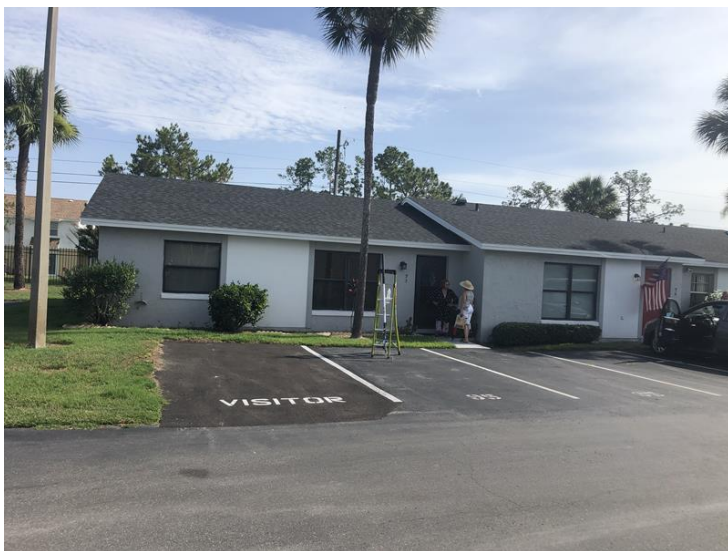
Roof Construction

| <b>3. Roof Deck Attachment:</b><br>Comments: | <b>Level C</b><br>Inspection verified 1/2" plywood roof deck attached with 8d nails at a minimum 6" on the edge & 6" in the field. |
| <b>4. Roof to Wall Attachment:</b><br>Comments: | <b>Toe Nails</b><br>Inspection verified embedded straps fastened with less than three nails. |
| <b>6. SWR:</b><br>Comments: | <b>No</b><br>Inspection verified no secondary water resistance. |
