Windstorm Mitigation Report (OIR-B1-1802)

Lake Villas Q and R Homeowners Association, Inc.

50-53 Lake Villa Way

As of 6/14/2022 | FPAT File# MUD2214404

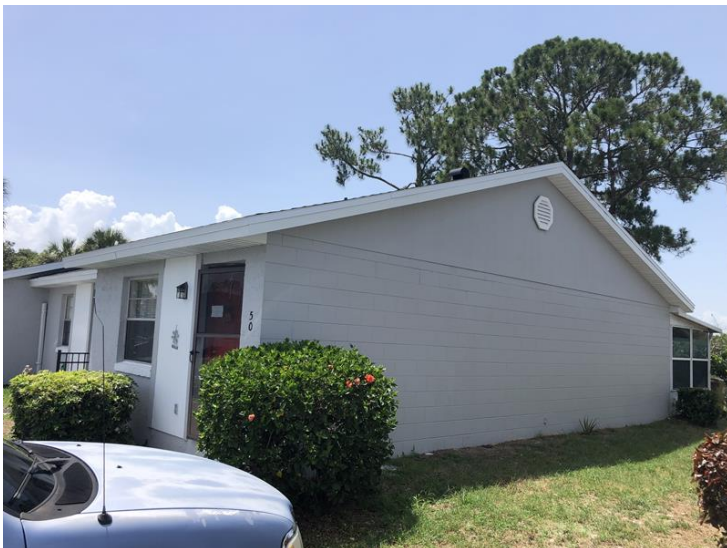
Exterior Elevation

Comments: | Other Roof
Inspection verified a gable roof shape. |

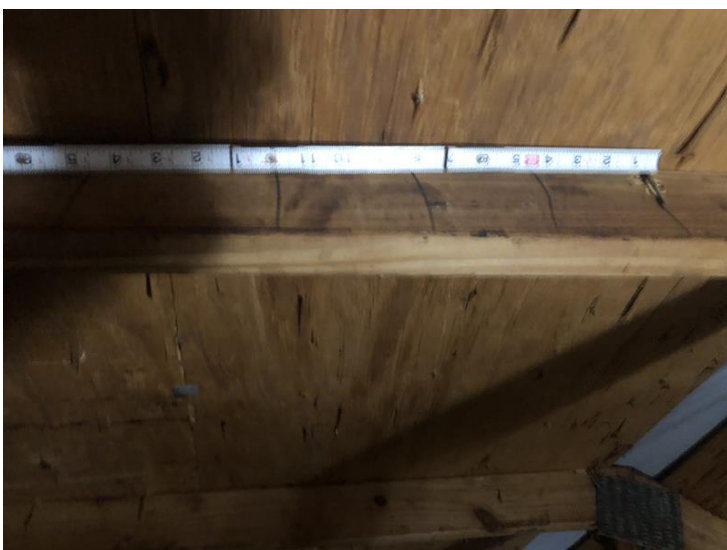
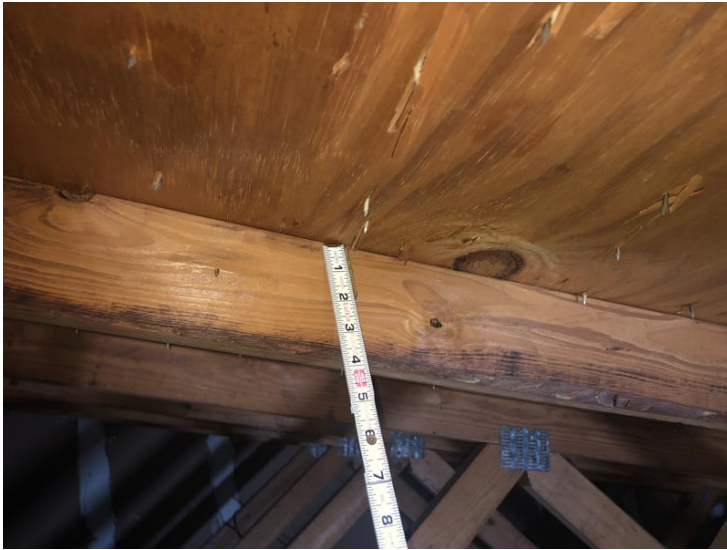
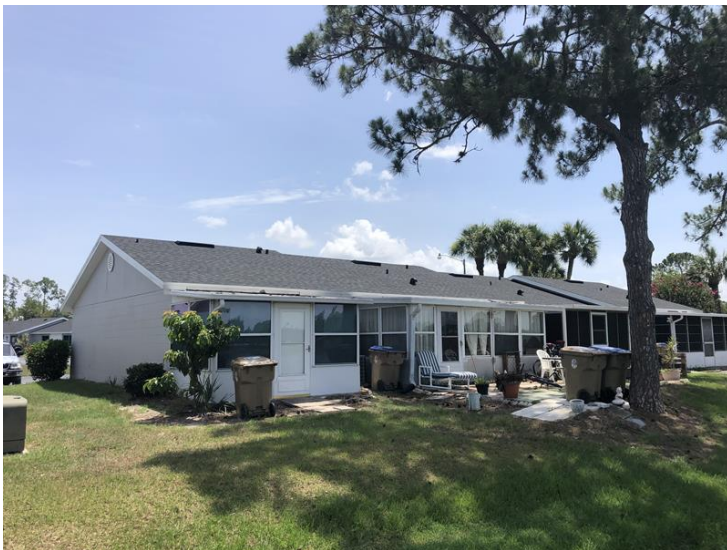
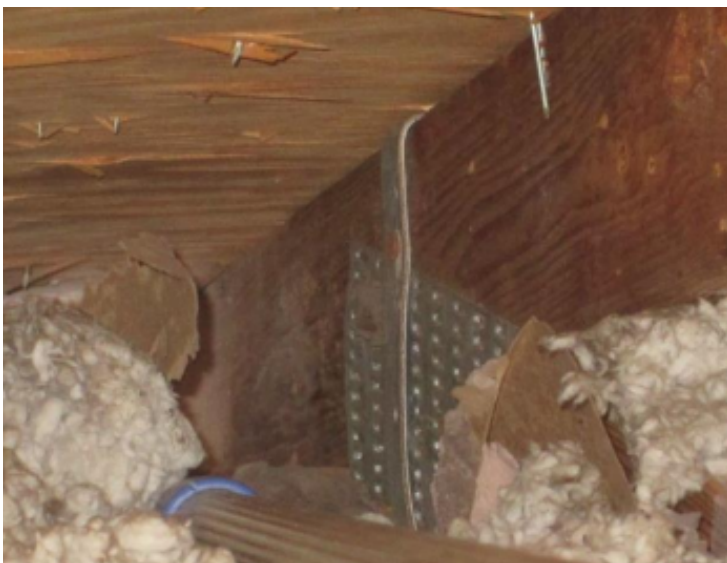
Roof Construction

Comments: | Level C
Inspection verified 1/2" plywood roof deck attached with 8d nails at a minimum 6" on the edge & 6" in the field. |

Comments: | Toe Nails
Inspection verified embedded straps fastened with less than three nails. |

Comments: | No
Inspection verified no secondary water resistance. |
