## Windstorm Mitigation Report (OIR-B1-1802)

Lake Villas Q and R Homeowners Association, Inc.

114-118 Lake Villa Way

As of 6/14/2022 | FPAT File# MUD2214404

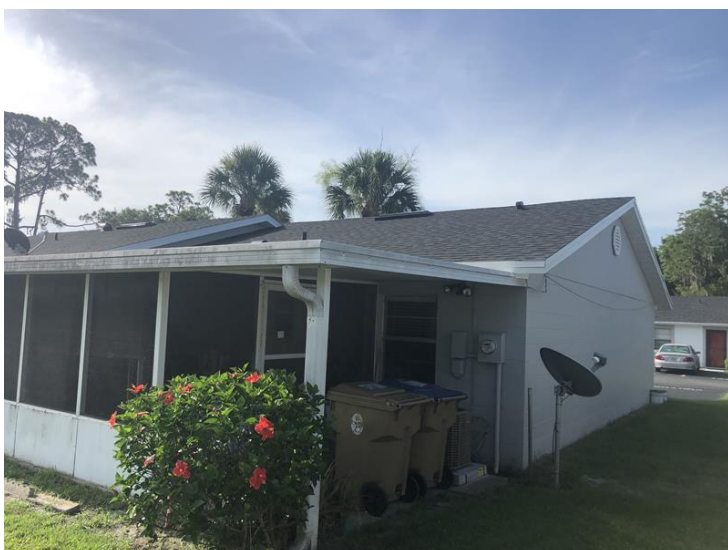
Exterior Elevation

| <b>5. Roof Geometry:</b><br>Comments: | <b>Other Roof</b><br>Inspection verified a gable roof shape. |

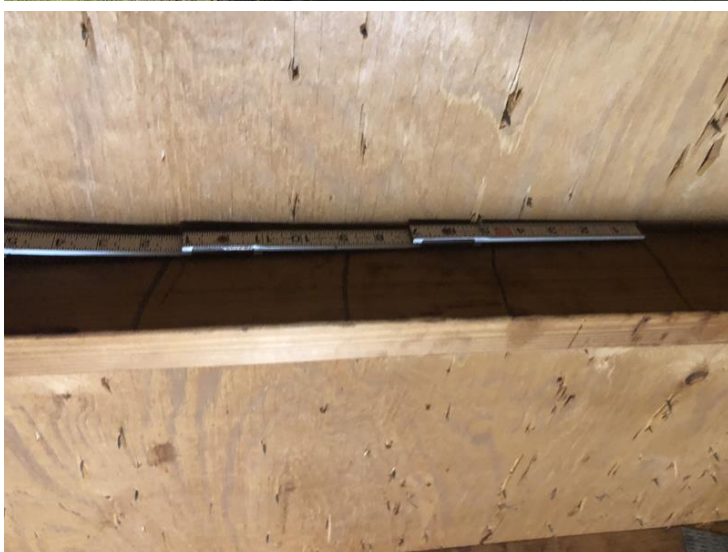
Roof Construction

| <b>3. Roof Deck Attachment:</b><br>Comments: | <b>Level C</b><br>Inspection verified 1/2" plywood roof deck attached with 8d nails at a minimum 6" on the edge & 6" in the field. |

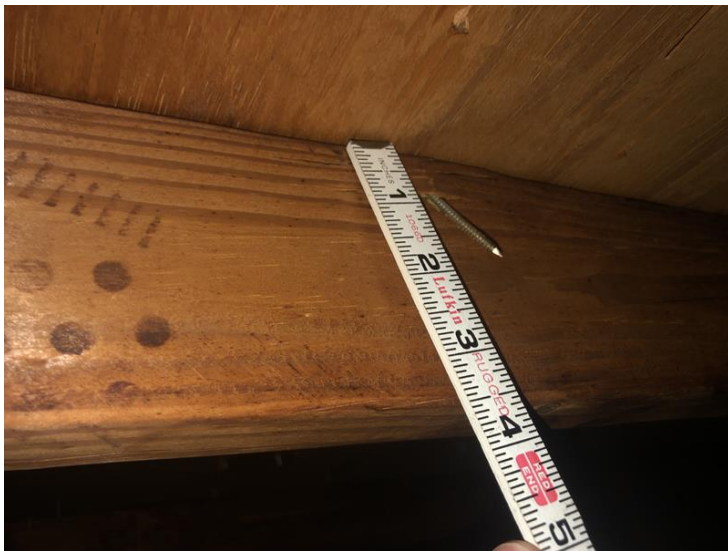
Roof Construction

| <b>4. Roof to Wall Attachment:</b><br>Comments: | <b>Toe Nails</b><br>Inspection verified embedded straps fastened with less than three nails. |

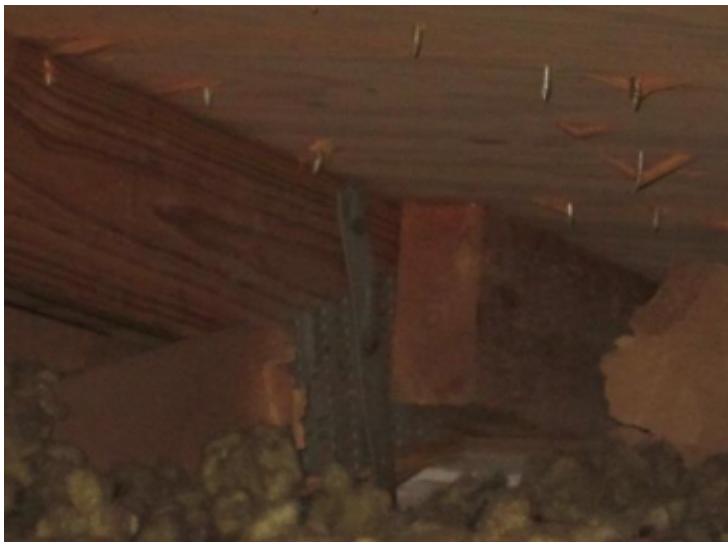
Roof Construction

| <b>6. SWR:</b><br>Comments: | <b>No</b><br>Inspection verified no secondary water resistance. |
