Windstorm Mitigation Report (OIR-B1-1802)

Lake Villas Q and R Homeowners Association, Inc.

119-121 Lake Villa Way

As of 6/14/2022 | FPAT File# MUD2214404

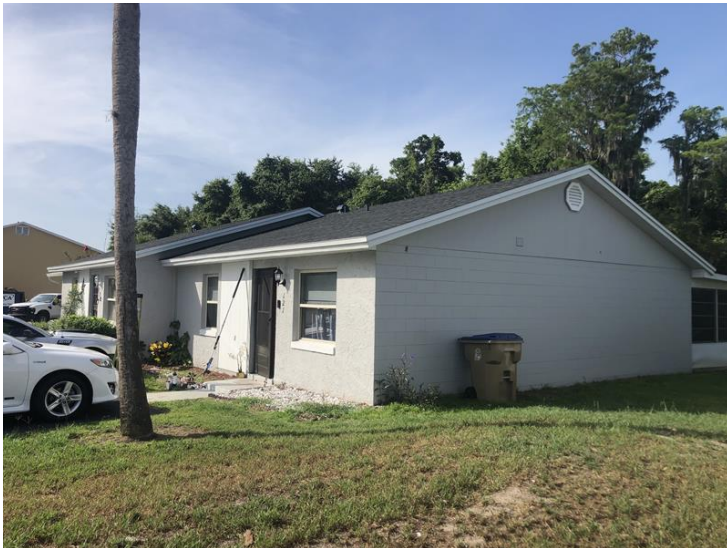
Exterior Elevation

Comments: | Other Roof
Inspection verified a gable roof shape. |

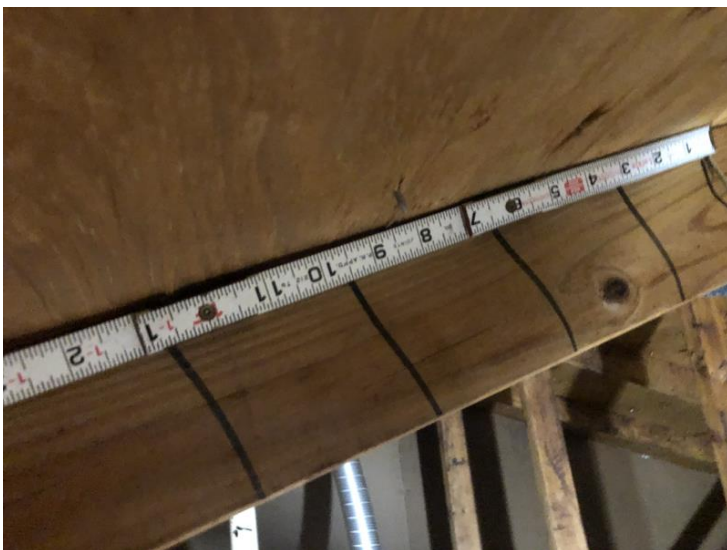
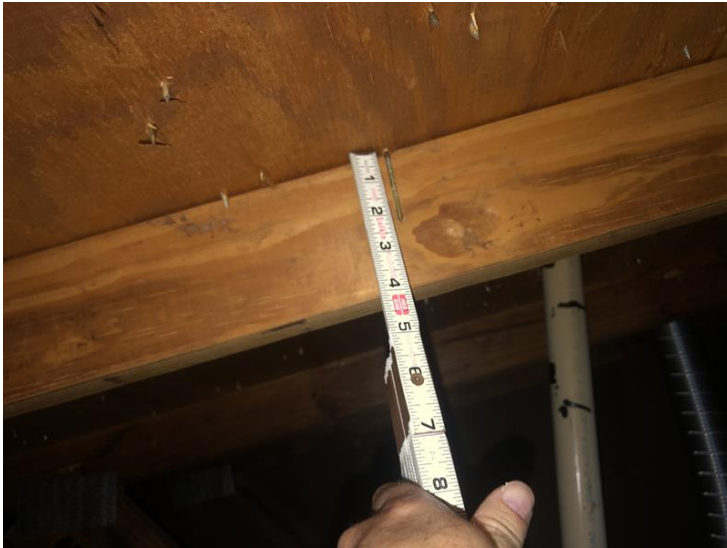
Roof Construction

Comments: | Level C
Inspection verified 1/2" plywood roof deck attached with 8d nails at a minimum 6" on the edge & 6" in the field. |

Comments: | Toe Nails
Inspection verified embedded straps fastened with less than three nails. |
