## Windstorm Mitigation Report (OIR-B1-1802)

Lake Villas Q and R Homeowners Association, Inc.

59-64 Lake Villa Way

As of 6/14/2022 | FPAT File# MUD2214404

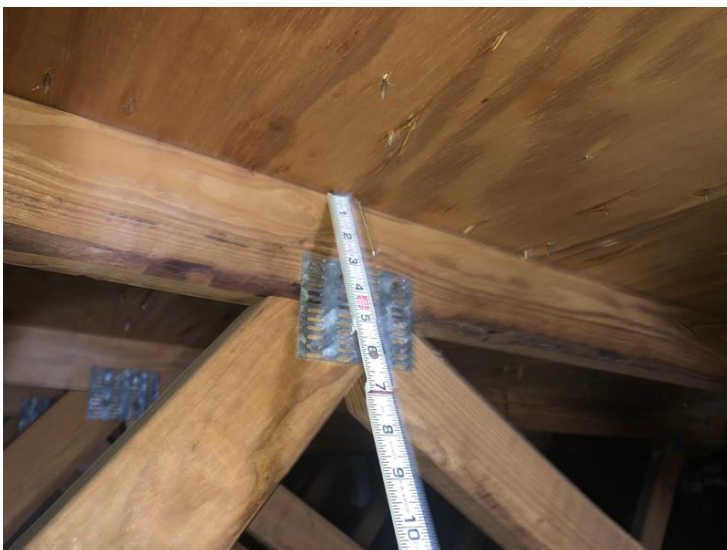
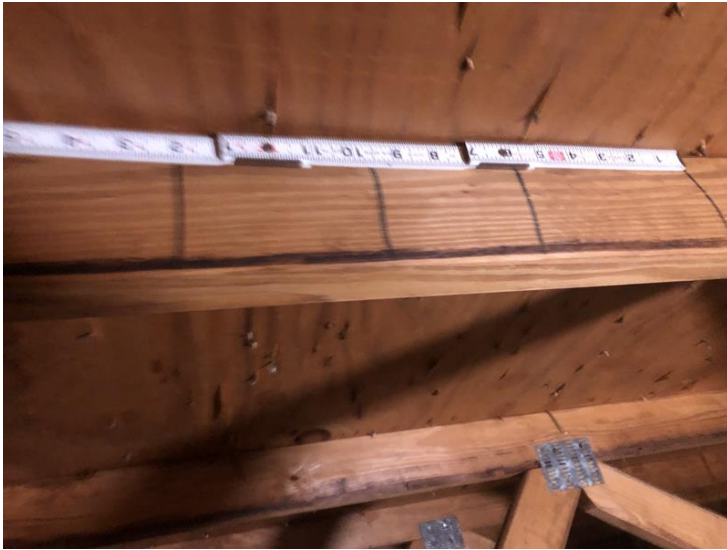
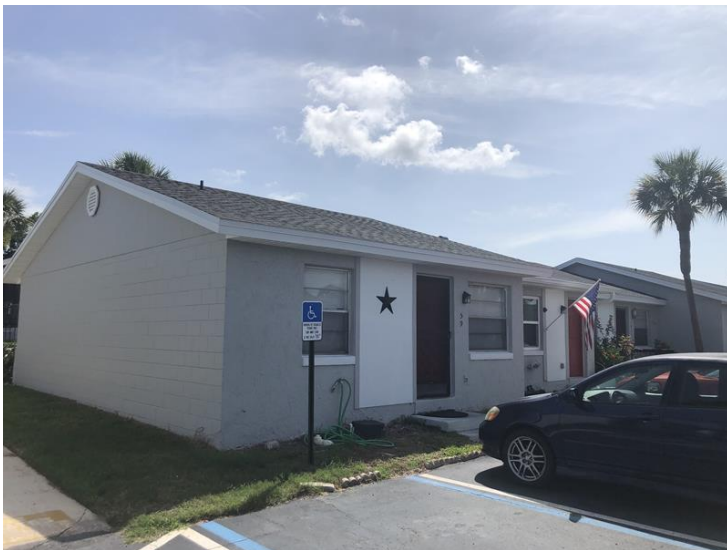
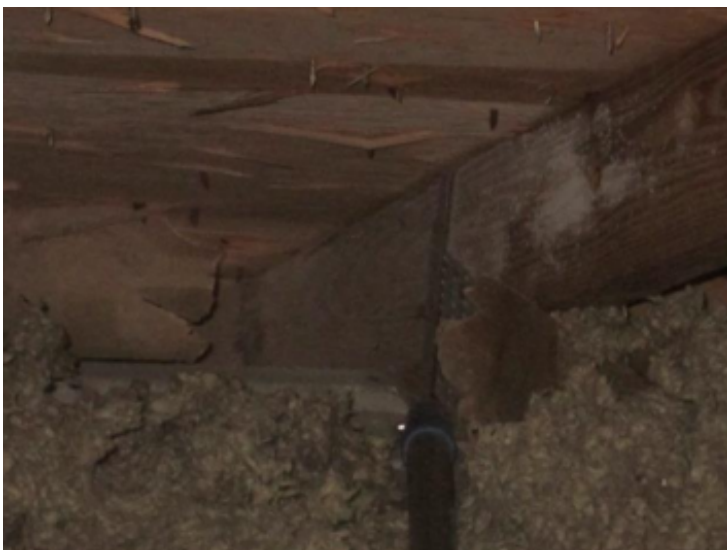
Roof Construction

| <b>3. Roof Deck Attachment:</b><br>Comments: | <b>Level C</b><br>Inspection verified 1/2" plywood roof deck attached with 8d nails at a minimum 6" on the edge & 6" in the field. |
| <b>4. Roof to Wall Attachment:</b><br>Comments: | <b>Toe Nails</b><br>Inspection verified embedded straps fastened with less than three nails. |
| <b>5. Roof Geometry:</b><br>Comments: | <b>Other Roof</b><br>Inspection verified a gable roof shape. |
| <b>6. SWR:</b><br>Comments: | <b>No</b><br>Inspection verified no secondary water resistance. |
