Windstorm Mitigation Report (OIR-B1-1802)

Lake Villas Q and R Homeowners Association, Inc.

1-3 Lake Villa Way

As of 6/14/2022 | FPAT File# MUD2214404

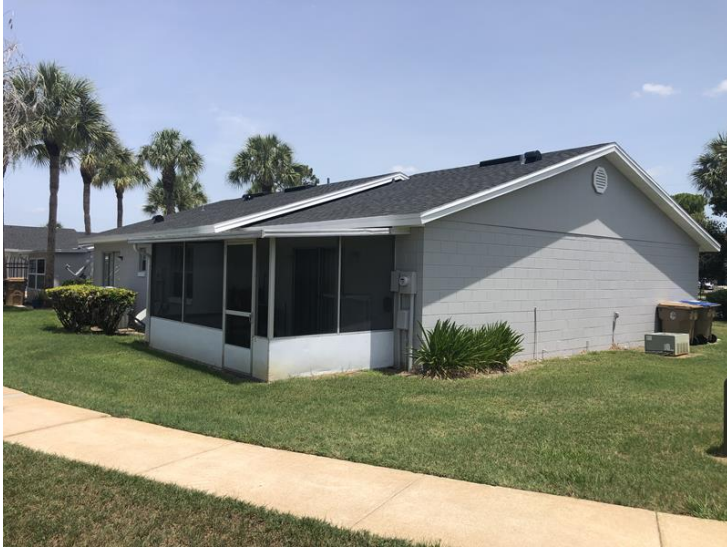
Exterior Elevation

| 5. Roof Geometry: Comments: | Other Roof Inspection verified a gable roof shape. |

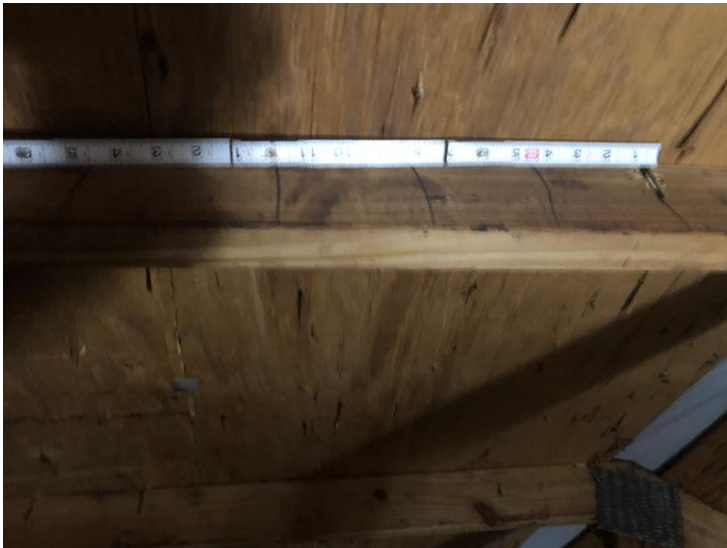
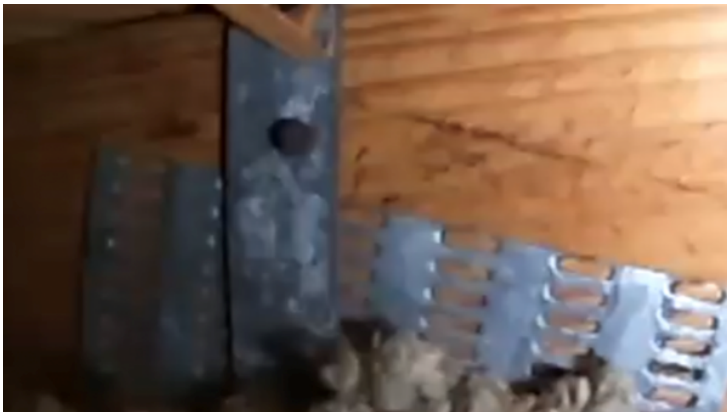
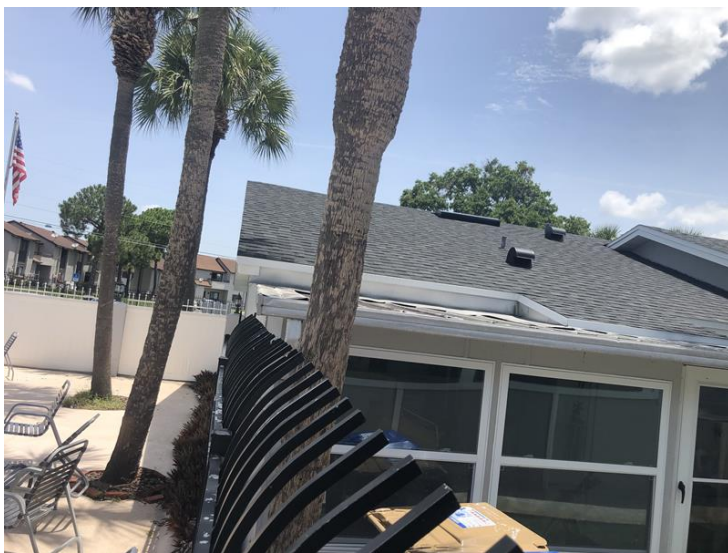
Roof Construction

| 3. Roof Deck Attachment: Comments: | Level C Inspection verified 1/2" plywood roof deck attached with 8d nails at a minimum 6" on the edge & 6" in the field. |
| 4. Roof to Wall Attachment: Comments: | Toe Nails Inspection verified embedded straps fastened with less than three nails. |
| 6. SWR: Comments: | No Inspection verified no secondary water resistance. |
