Windstorm Mitigation Report (OIR-B1-1802)

Lake Villas Q and R Homeowners Association, Inc.

99-101 Lake Villa Way

As of 6/14/2022 | FPAT File# MUD2214404

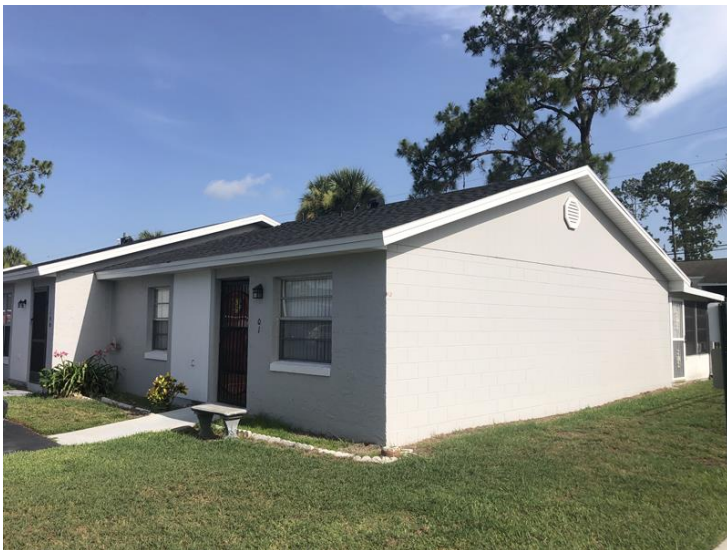
Exterior Elevation

Comments: | Other Roof
Inspection verified a gable roof shape. |

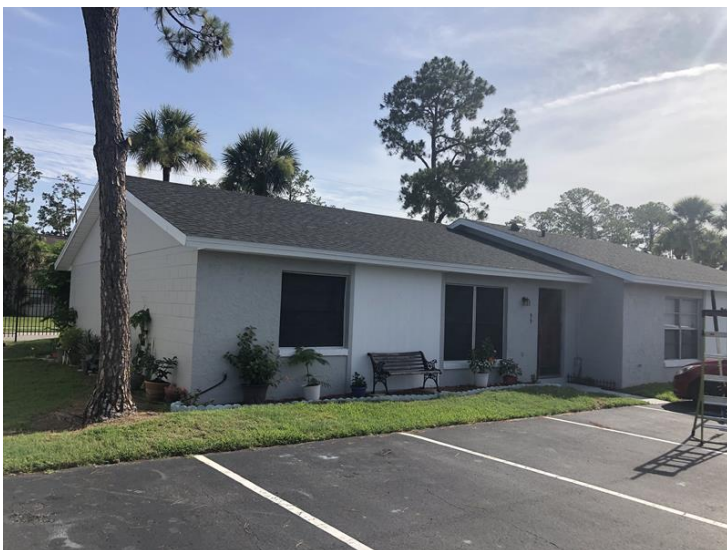
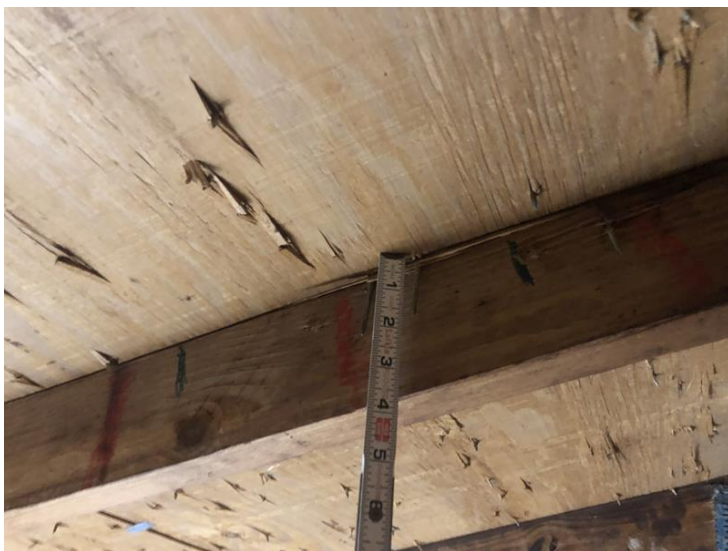
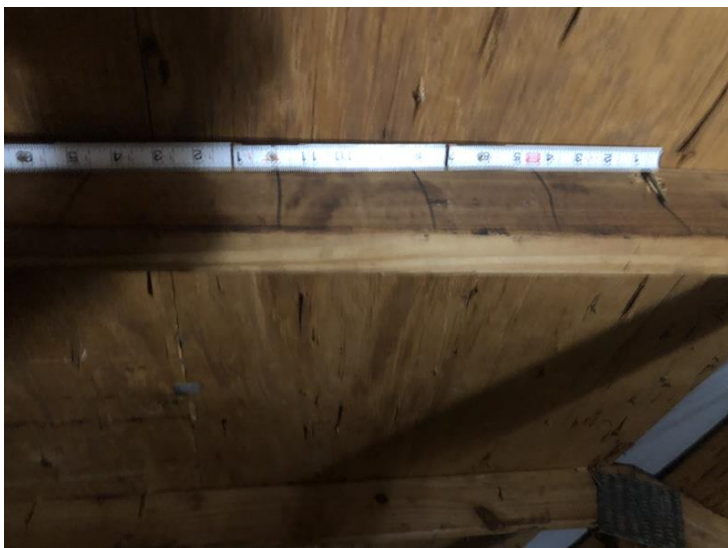
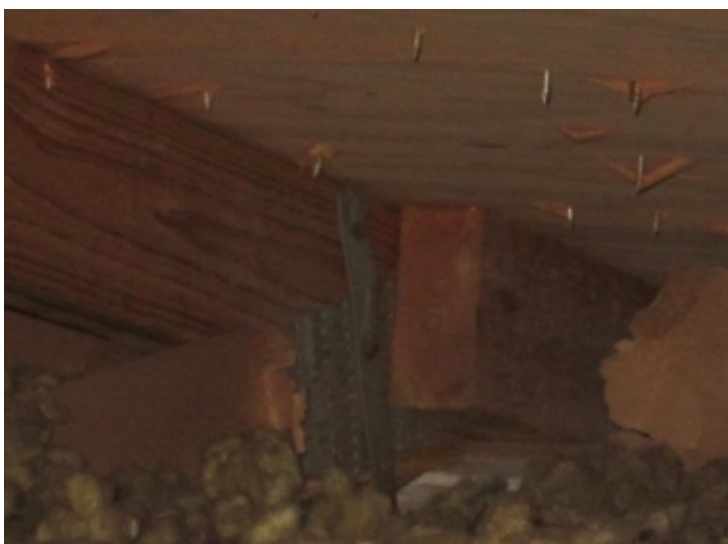
Roof Construction

Comments: | Level C
Inspection verified 1/2" plywood roof deck attached with 8d nails at a minimum 6" on the edge & 6" in the field. |

Comments: | Toe Nails
Inspection verified embedded straps fastened with less than three nails. |

Comments: | No
Inspection verified no secondary water resistance. |
