## Windstorm Mitigation Report (OIR-B1-1802)

Lake Villas Q and R Homeowners Association, Inc.

65-69 Lake Villa Way

As of 6/14/2022 | FPAT File# MUD2214404

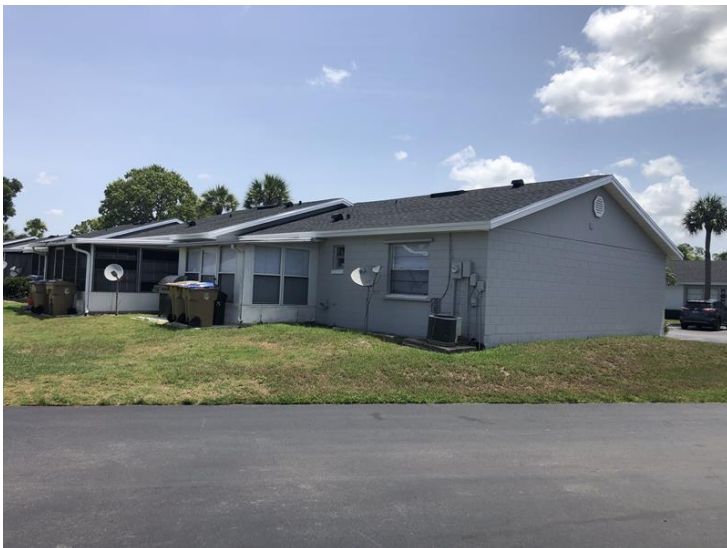
Exterior Elevation

| <b>5. Roof Geometry:</b><br>Comments: | <b>Other Roof</b><br>Inspection verified a gable roof shape. |
| <b>7. Opening Protection:</b><br>Comments: | <b>None or Some Glazed Openings</b><br>Inspection verified some metal shutter opening protection. Not all glazed openings were protected with impact resistant coverings. |

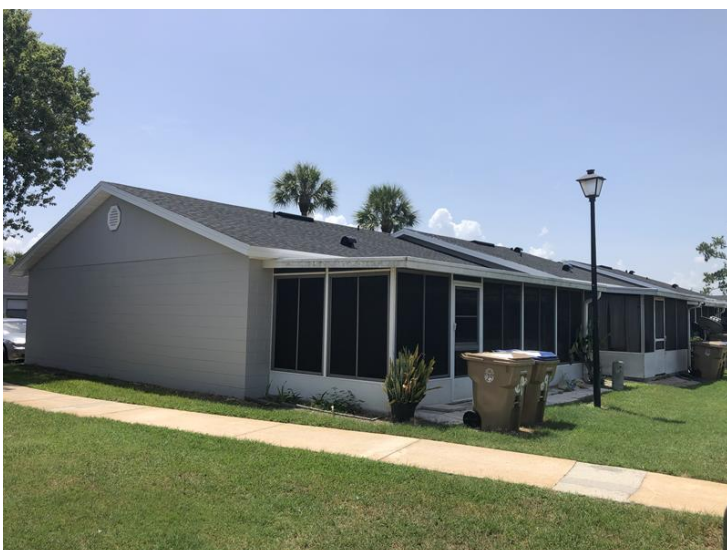
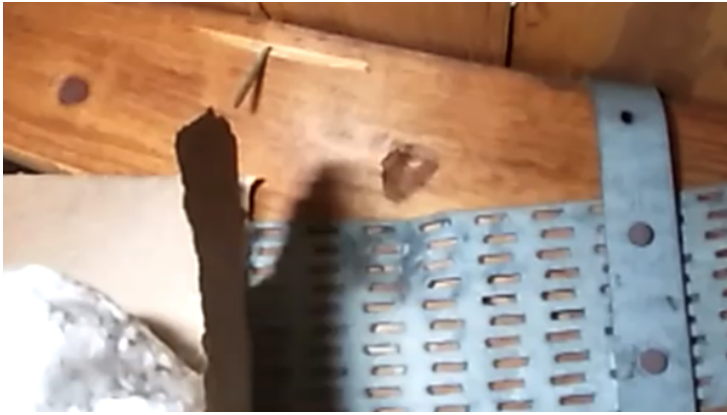
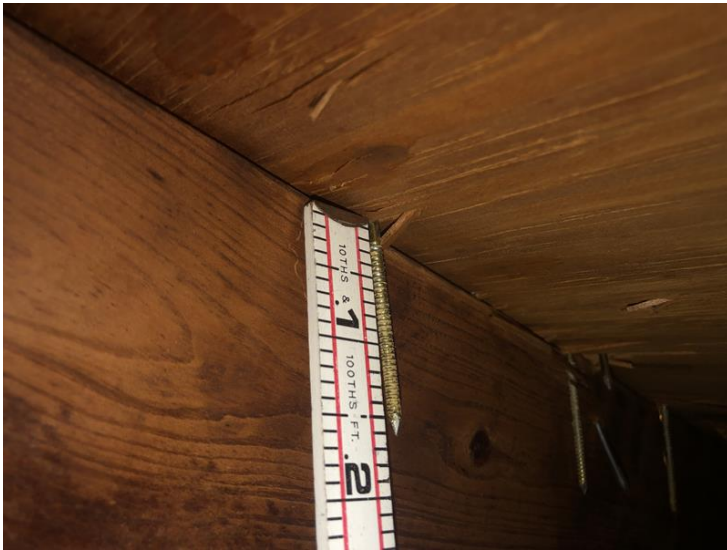
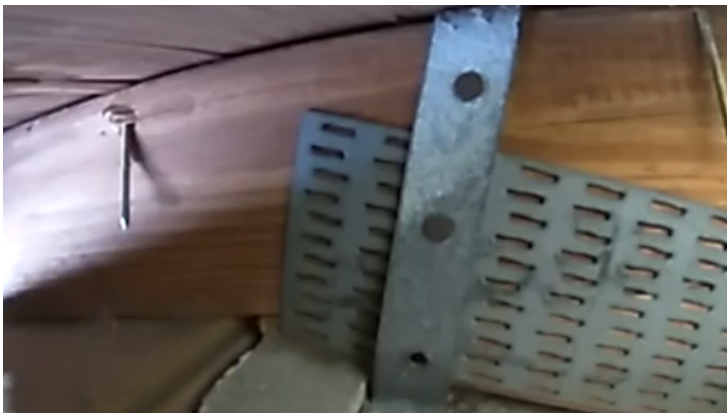
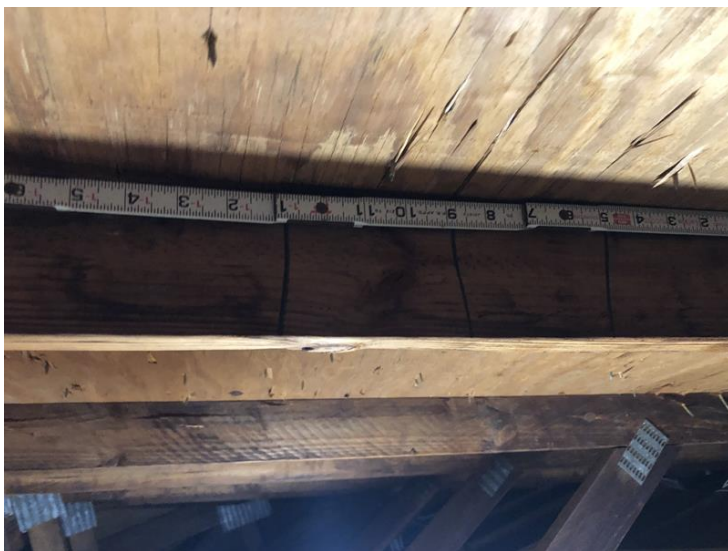
Roof Construction

| <b>3. Roof Deck Attachment:</b><br>Comments: | <b>Level C</b><br>Inspection verified 1/2" plywood roof deck attached with 8d nails at a minimum 6" on the edge & 6" in the field. |
| <b>4. Roof to Wall Attachment:</b><br>Comments: | <b>Toe Nails</b><br>Inspection verified embedded straps fastened with less than three nails. |
| <b>6. SWR:</b><br>Comments: | <b>No</b><br>Inspection verified no secondary water resistance. |
