## Windstorm Mitigation Report (OIR-B1-1802)

Lake Villas Q and R Homeowners Association, Inc.

70-72 Lake Villa Way

As of 6/14/2022 | FPAT File# MUD2214404

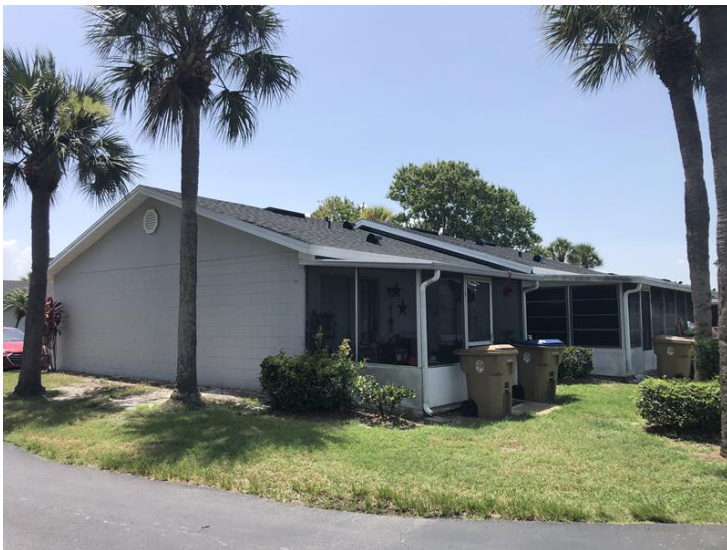
Exterior Elevation

| <b>5. Roof Geometry:</b><br>Comments: | <b>Other Roof</b><br>Inspection verified a gable roof shape. |

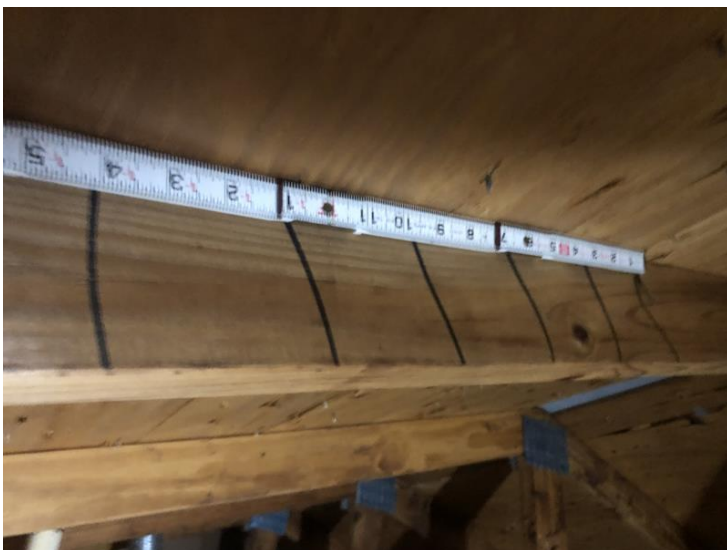
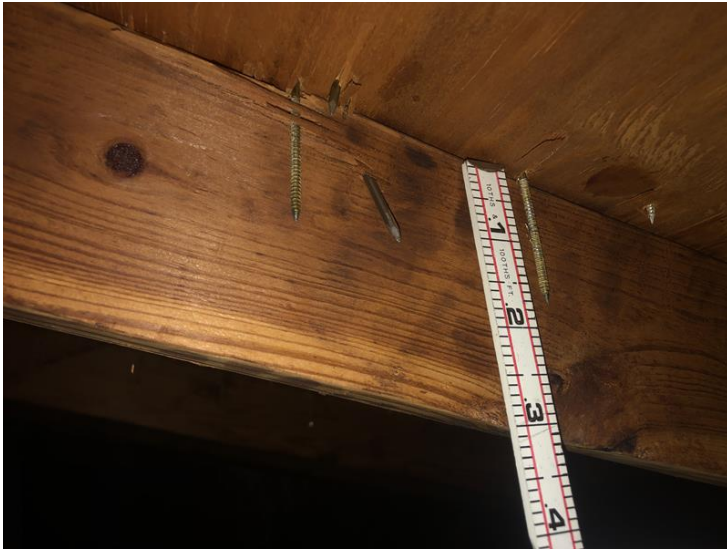
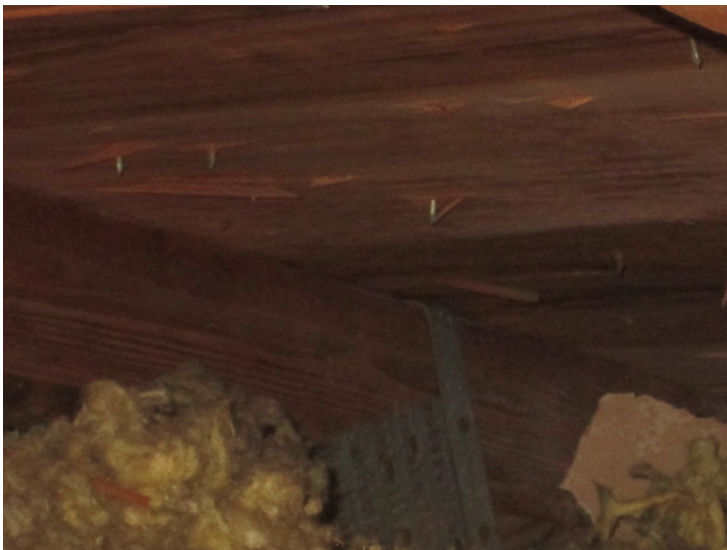
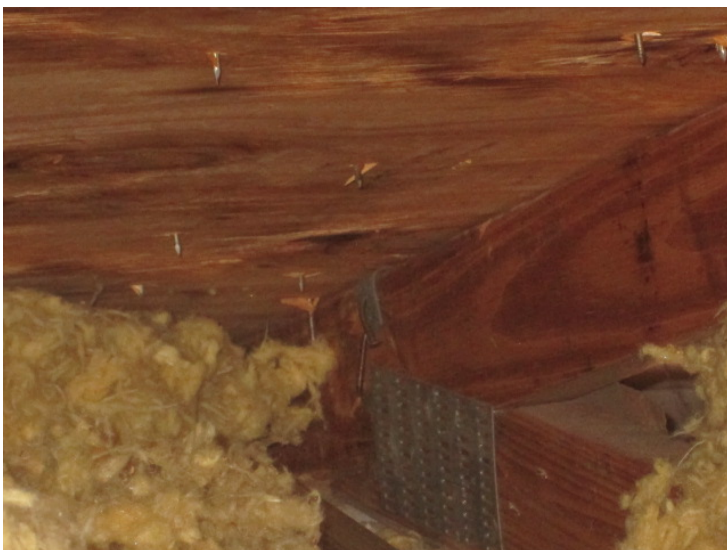
Roof Construction

| <b>3. Roof Deck Attachment:</b><br>Comments: | <b>Level C</b><br>Inspection verified 1/2" plywood roof deck attached with 8d nails at a minimum 6" on the edge & 6" in the field. |
| <b>4. Roof to Wall Attachment:</b><br>Comments: | <b>Single Wraps</b><br>Single wraps were verified during our attic inspection as the roof wall connection. Each single wrap has a minimum of two nails on the front of the truss and one nail on the opposite side. |
