## Windstorm Mitigation Report (OIR-B1-1802)

Lake Villas Q and R Homeowners Association, Inc.

4 Lake Villa Way, Clubhouse

As of 6/14/2022 | FPAT File# MUD2214404

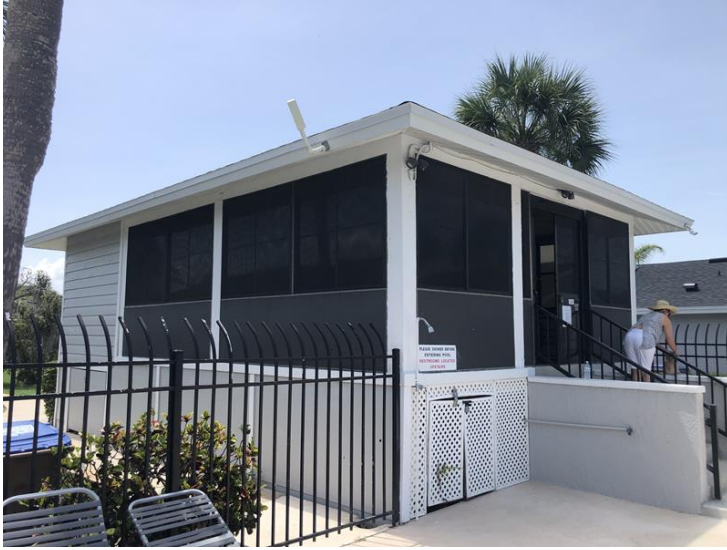
Exterior Elevation

| <b>5. Roof Geometry:</b><br>Comments: | <b>Hip Roof</b><br>Inspection verified a hip roof shape. |

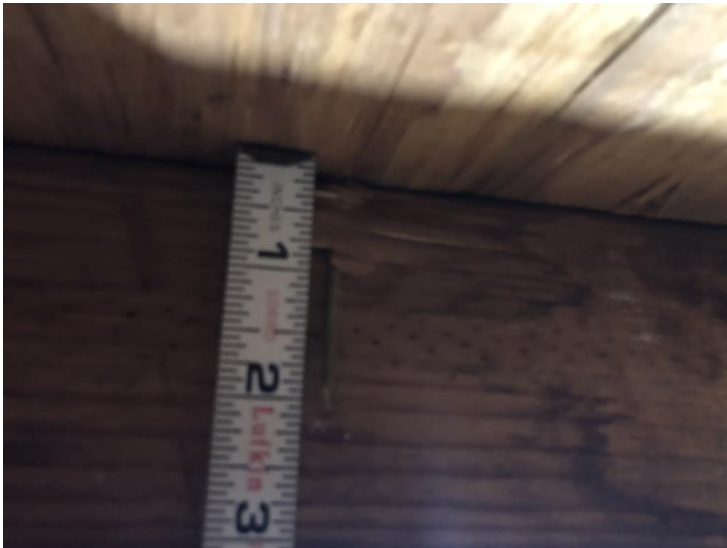
Roof Construction

| <b>3. Roof Deck Attachment:</b><br>Comments: | <b>Level C</b><br>Inspection verified 1/2" plywood roof deck attached with 8d nails at a minimum 6" on the edge & 6" in the field. |

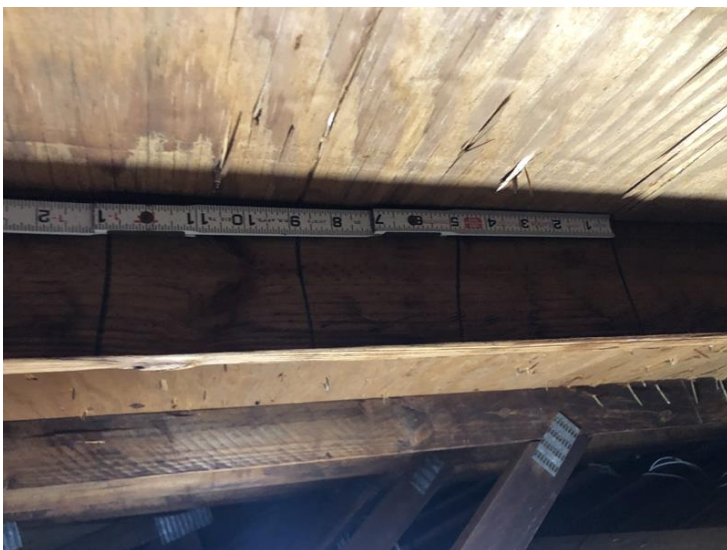
Roof Construction

| <b>4. Roof to Wall Attachment:</b><br>Comments: | <b>Clips</b><br>Inspection verified hurricane clips fastened with a minimum of three nails. |
