Windstorm Mitigation Report (OIR-B1-1802)

Lake Villas Q and R Homeowners Association, Inc.

5-10 Lake Villa Way

As of 6/14/2022 | FPAT File# MUD2214404

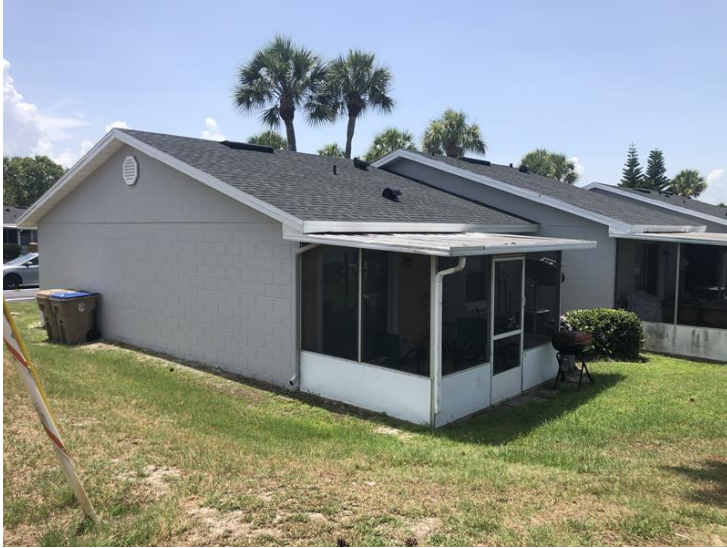
Exterior Elevation

Comments: | Other Roof
Inspection verified a gable roof shape. |

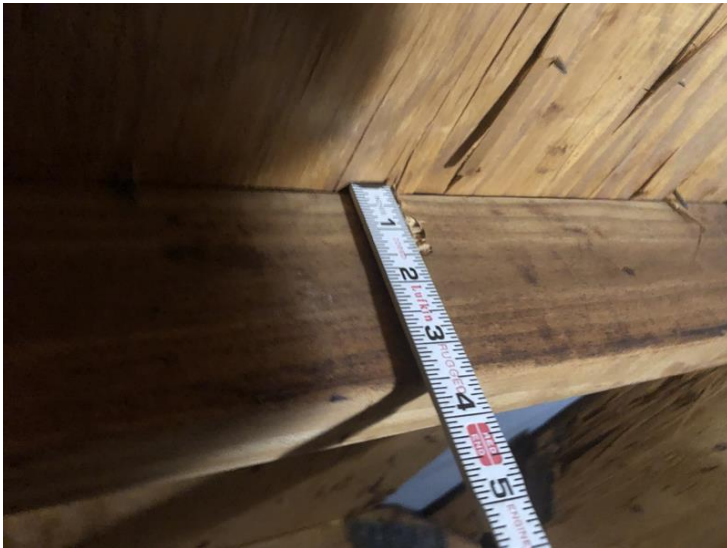
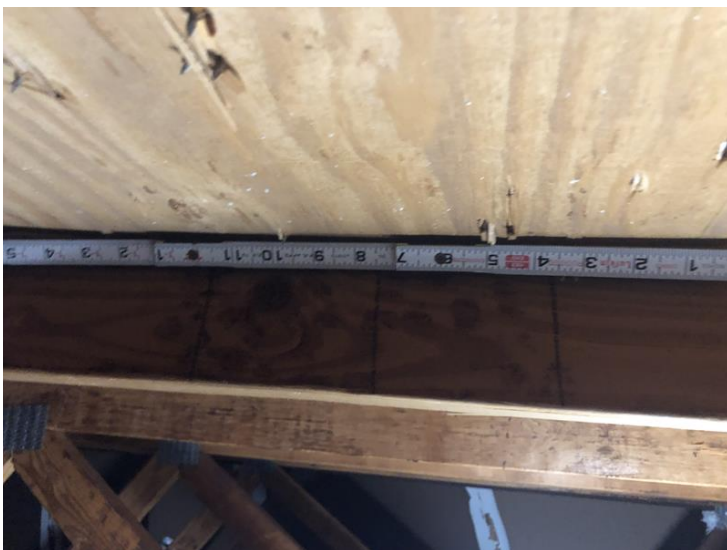
Roof Construction

Comments: | Level C
Inspection verified 1/2" plywood roof deck attached with 8d nails at a minimum 6" on the edge & 6" in the field. |

Comments: | Toe Nails
Inspection verified embedded straps fastened with less than three nails. |

Comments: | No
Inspection verified no secondary water resistance. |
